Modelling of the HMAS Westralia Fire

DSTO-TR-0698

MODELLING OF THE HMAS WESTRALIA FIRE

The HMAS Westralia fire incident of 5 May 1998, involved the combustion of a quantity of diesel fuel in the engine compartment. Four sailors were killed and the ship disabled.

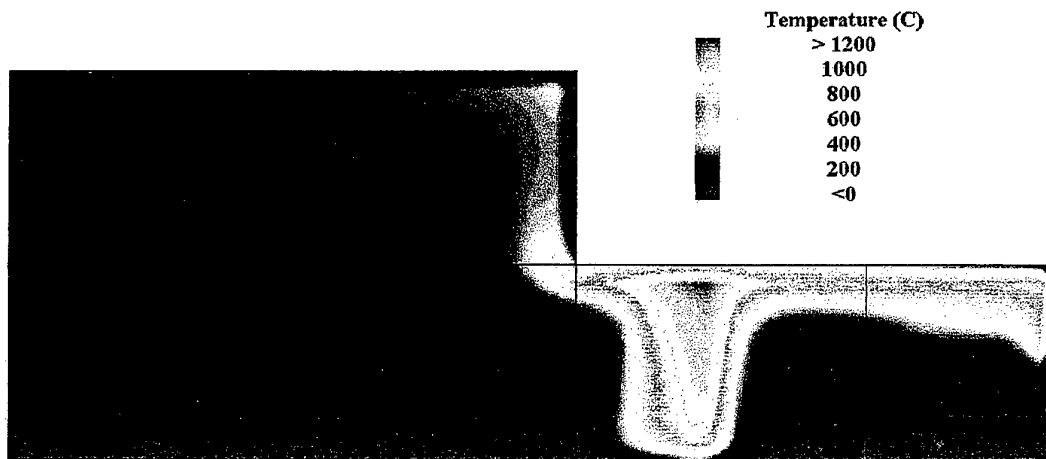
The starboard bulkhead adjacent to the fire source and the deckhead directly above the fire source (the deck of the MCR) were subjected to the most intense heat. Figure 6 depicts the predicted temperature distribution 1 minute into the model incident for a plane through the model along the starboard bulkhead adjacent to the starboard engine. Temperatures of greater than 1200°C are predicted near the top of the wall.

Figure 6. The temperature distribution of the fire incident on a section through the wall adjacent to the starboard engine is shown. Viewed from the starboard side. The thick black lines indicate the positions of the lower and upper mezzanine floors.

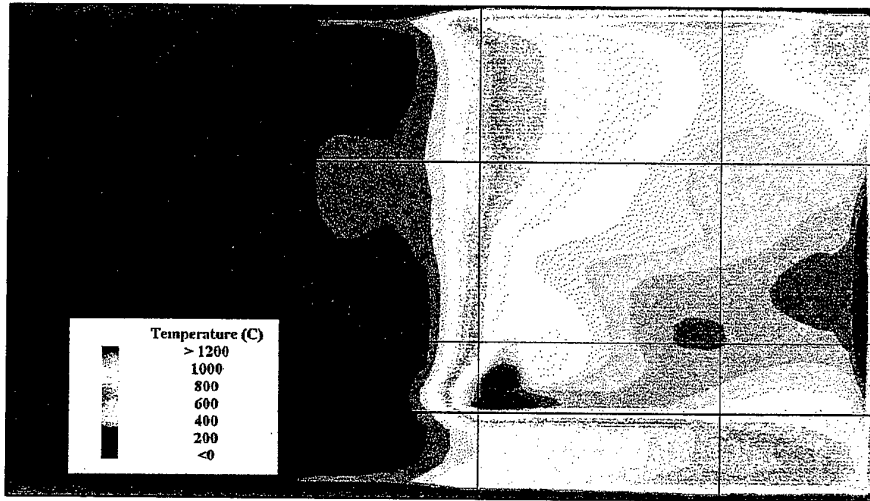
The temperature distribution under the MCR is of interest since this is where significant damage was done to the cabelling and the 3 tonne lifting rail directly above the fire source. Very high temperatures are indicated in the region of the cables ($>1200^{\circ}\text{C}$) and in the area above the cargo pumps. The temperature distribution predicted for a horizontal plane 0.5 m below the MCR floor is shown in Figure 8. The

Figure 8. The temperature distribution is shown, viewed from above, 0.5 metres below the MCR 1 minute into the event. A fireball is predicted to have spread across the whole of the underside of the MCR. The hottest spot is directly above the fire source. The wall adjacent to the starboard engine can be seen to effectively block the heat getting to the machinery behind it.

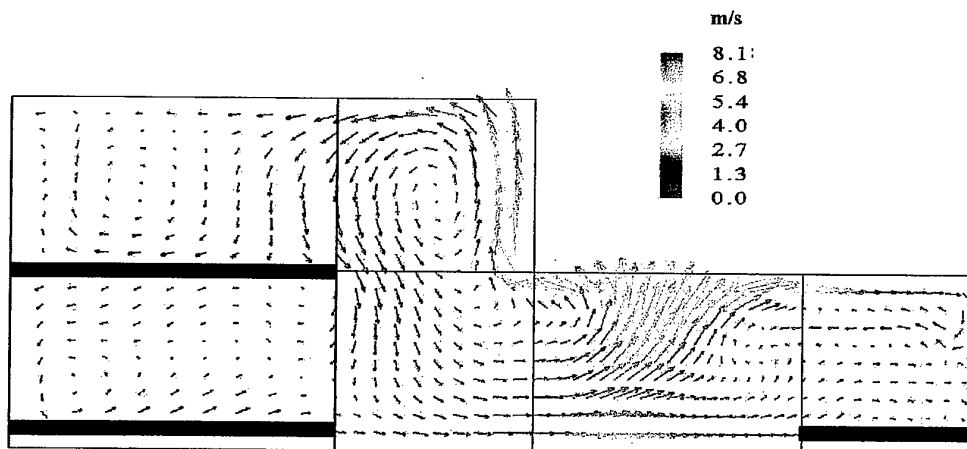
Figure 9. The bulk airflow of the compartment is depicted 1 minute into the incident for a forward vertical section through the fire source. The main area of concern is the flow above the cargo pumps where hot gases are directed down onto the top of the motors.

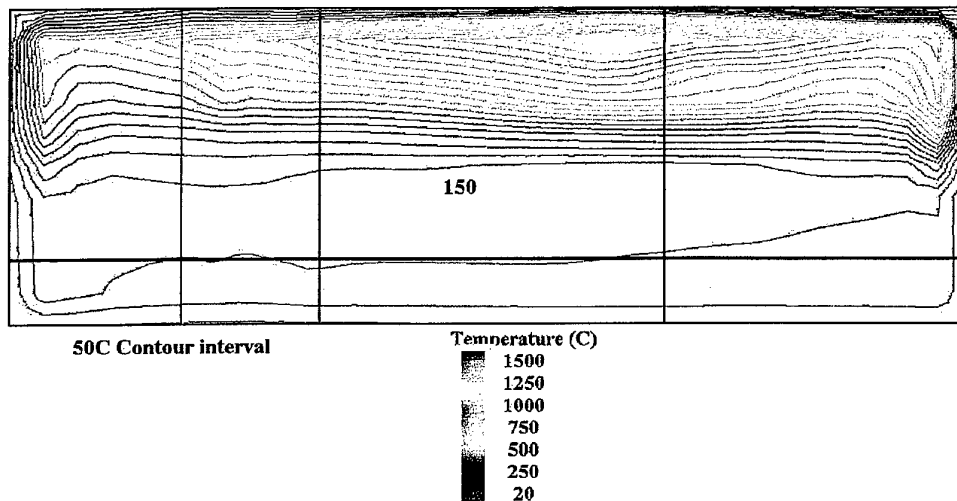
The exposure of the cargo pumps to high temperatures is of concern to the cost of repairs to the vessel. The predicted temperature contours is shown in Figure 10 for a section across the compartment through the location of the cargo pumps.

The 150 C isotherm is labeled and is significant as at this height the adhesive label was obtained from cargo pump number 3. A contour interval of 50°C was used in drawing the figure.

Figure 10. The isotherm predictions are shown, 1 minute into the incident, for a section through the cargo pumps area. The view is toward aft. Temperatures as high as 500C are predicted of the air at the tops of the pumps. The 150°C contour corresponds to the position of an adhesive label attached to the pump. An examination of a sample of this label suggests an exposure to a temperature of approximately 140°C.

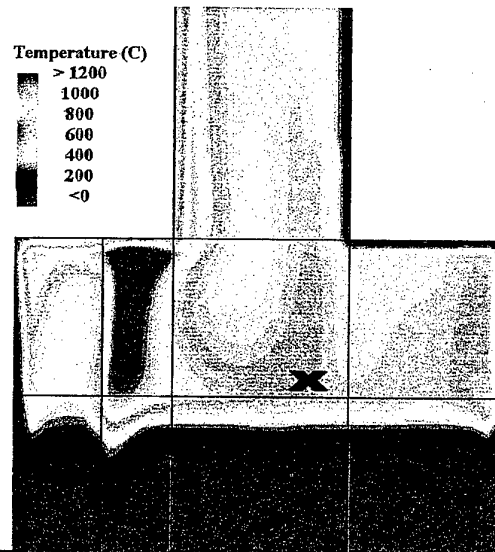
The model temperature predictions for the section just aft of the MCR looking aft are shown in Figure 12. The hot plume spilt from under the MCR can be seen to rise up the starboard side. Predicted temperatures of approximately 500 to 600°C would be experienced at the MCR level near the starboard escape ladder (marked with an X). This is consistent with the damage to the aluminium walkway, which softened and buckled during the incident. The top of the port escape ladder (marked with an X) also was predicted to be exposed to temperatures of 300 to 400°C, again consistent with the damage observed (paint blistered and burnt, light fitting difusers melted and signs damaged).

Figure 12. Temperature distribution 1 minute into the event for a cut across the compartment aft of the MCR looking aft. High temperatures of the order of 400°C are predicted to exist at the top of the port ladder (marked with an X).

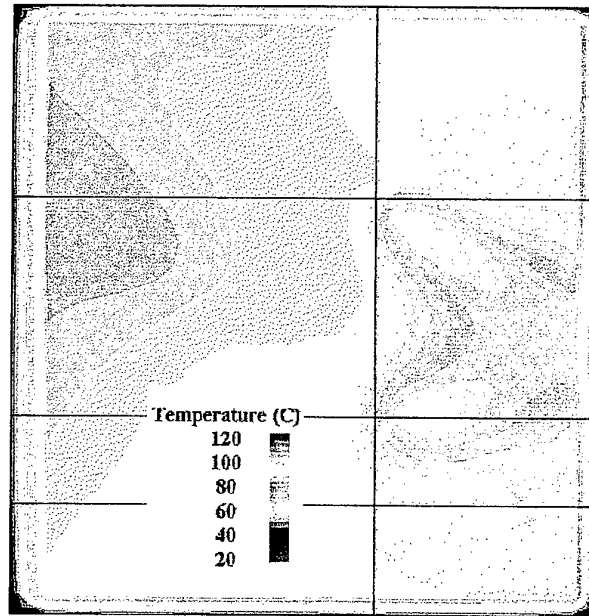
Figure 14. The temperature distribution is depicted 4 minutes into the fire incident at the level of the fridge flat. The residual temperatures at the aft end of the compartment, where the fire fighters attempted to re-enter the compartment, is still near 100°C and too hot for a reentry.
